Reliability and failure analysis *- case studies and typical failure modes*

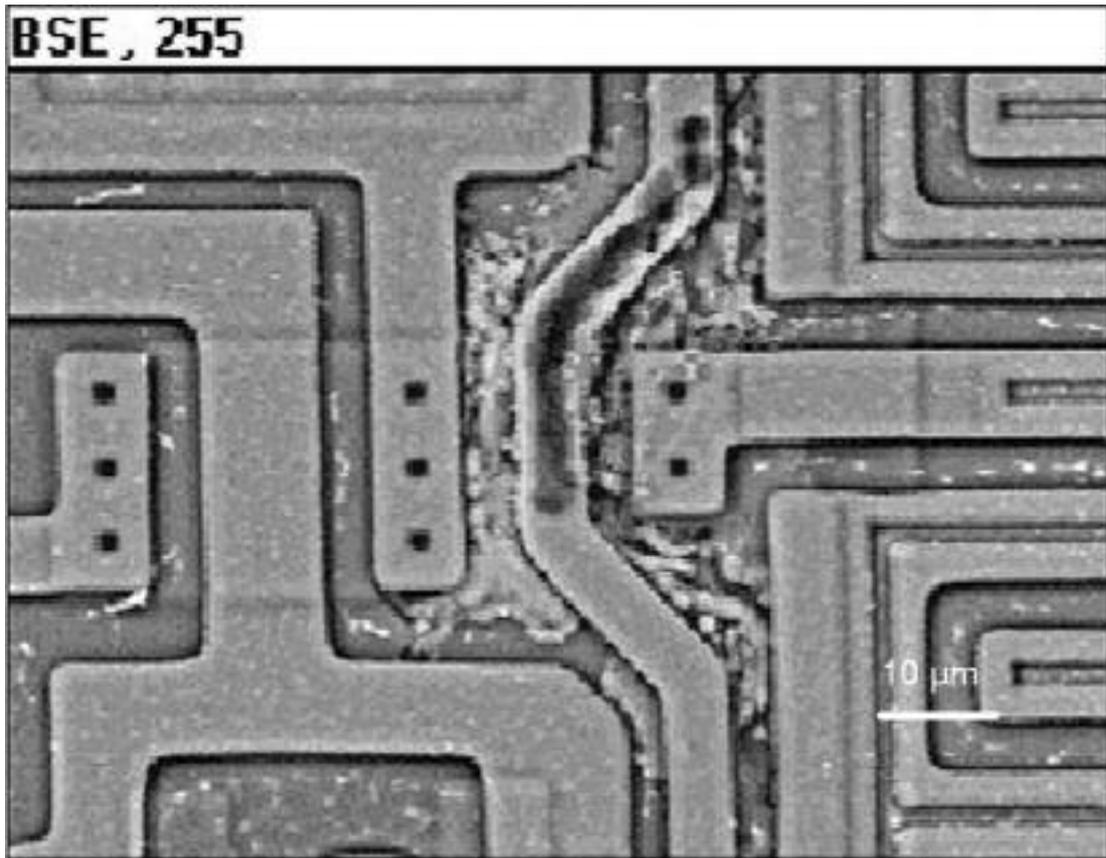
electrical over-stress in silicon IC

Back-scatter SEM image and false colour EDX data show loss of the surface aluminium layer (Al=red) and an increase in oxidation (O=Green) due to electrical over-stress in this protective circuit from a power switch IC.

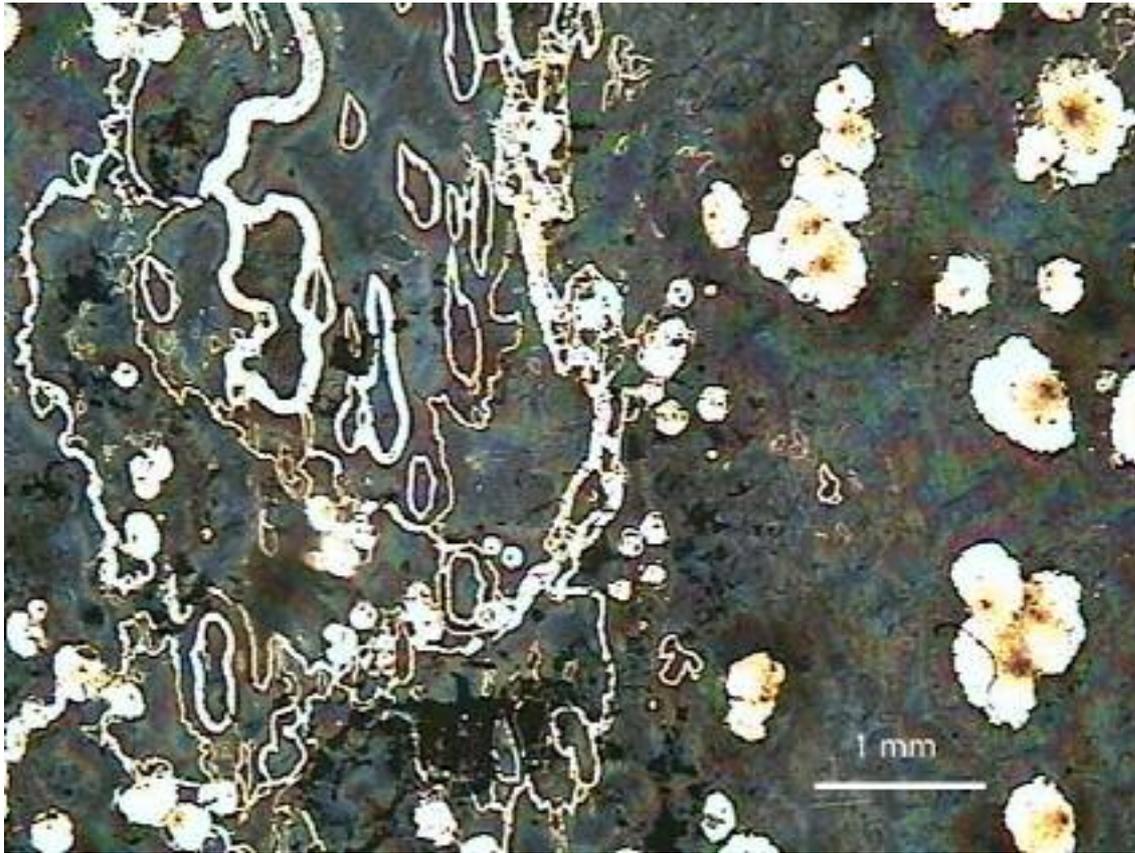
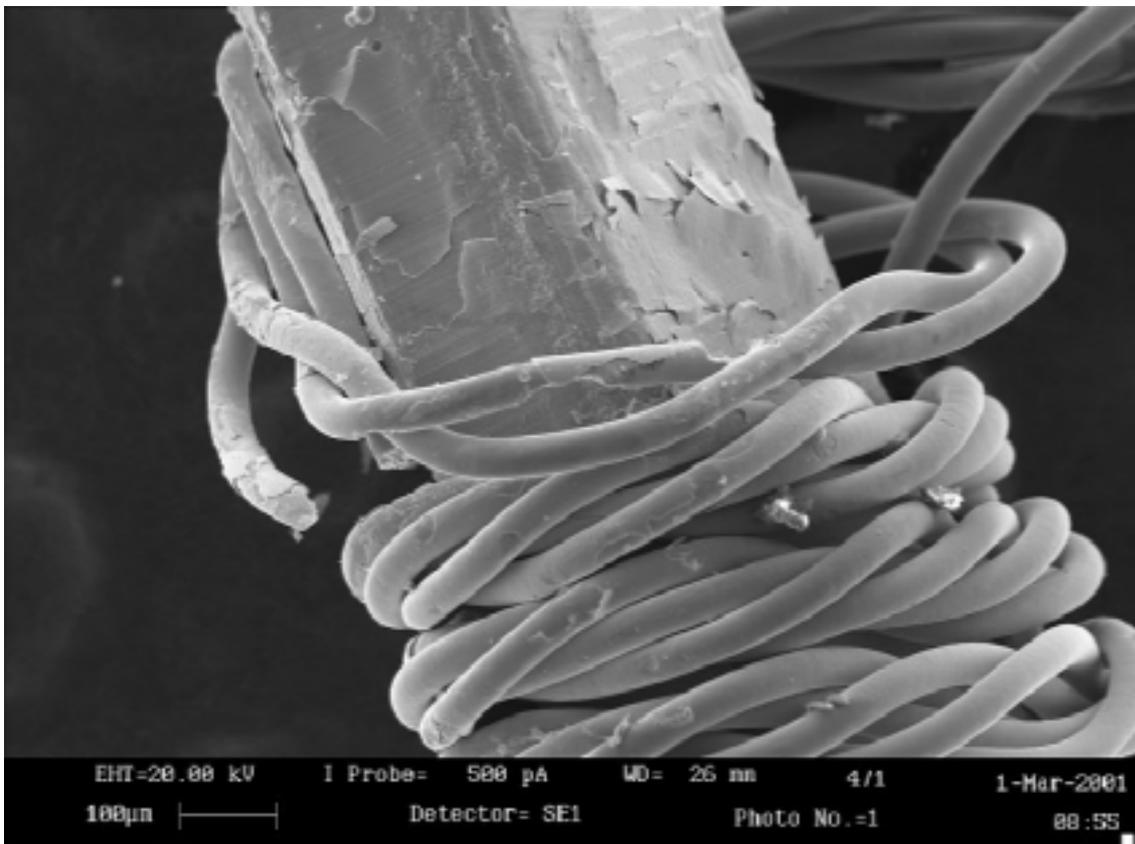
corrosion due to sulphur

The ends of fine copper wires for a coil were corroded by sulphur where the lacquer had been removed by welding the wire to the pillar. Stress corrosion cracking of the copper has also occurred.

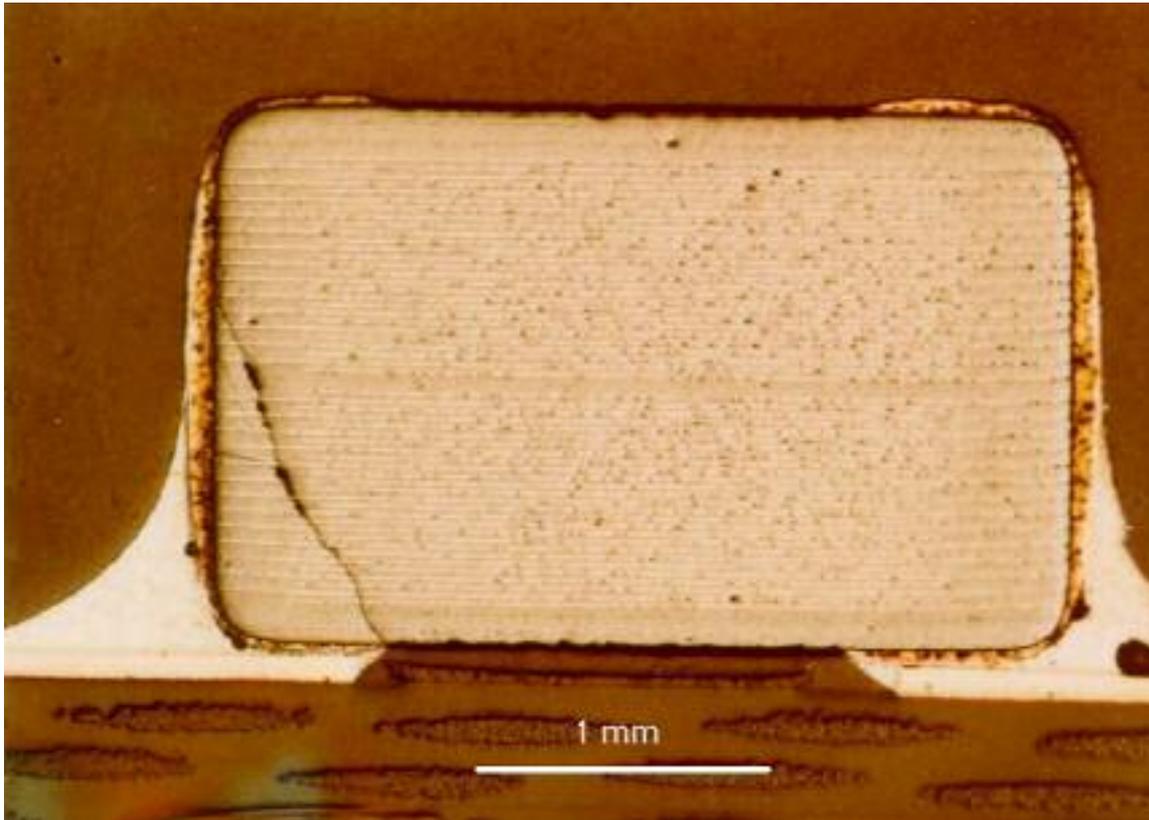
cracked SMT capacitor

Cross section of a ceramic chip capacitor where the fault was manifested after only six months' use. The crack was caused during board assembly but was not visible at the surface of the capacitor.

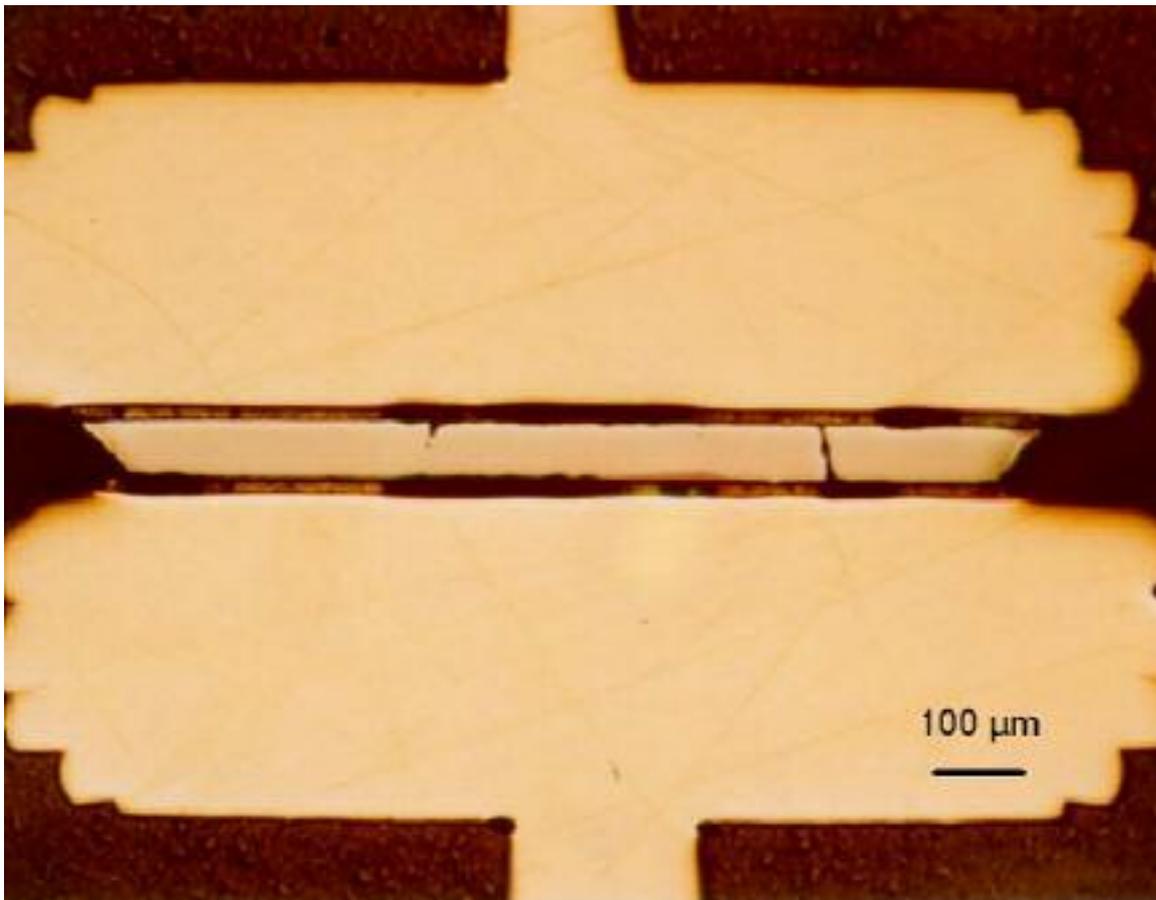
cracked diode

Optical photograph of a cross section through a failed diode showing cracks in the chip next to the (black) voids in the solder either side of the chip.
